# YELLOWSTONE COUNTY

TRAFFIC SAFETY

IMPROVEMENT

STUDY

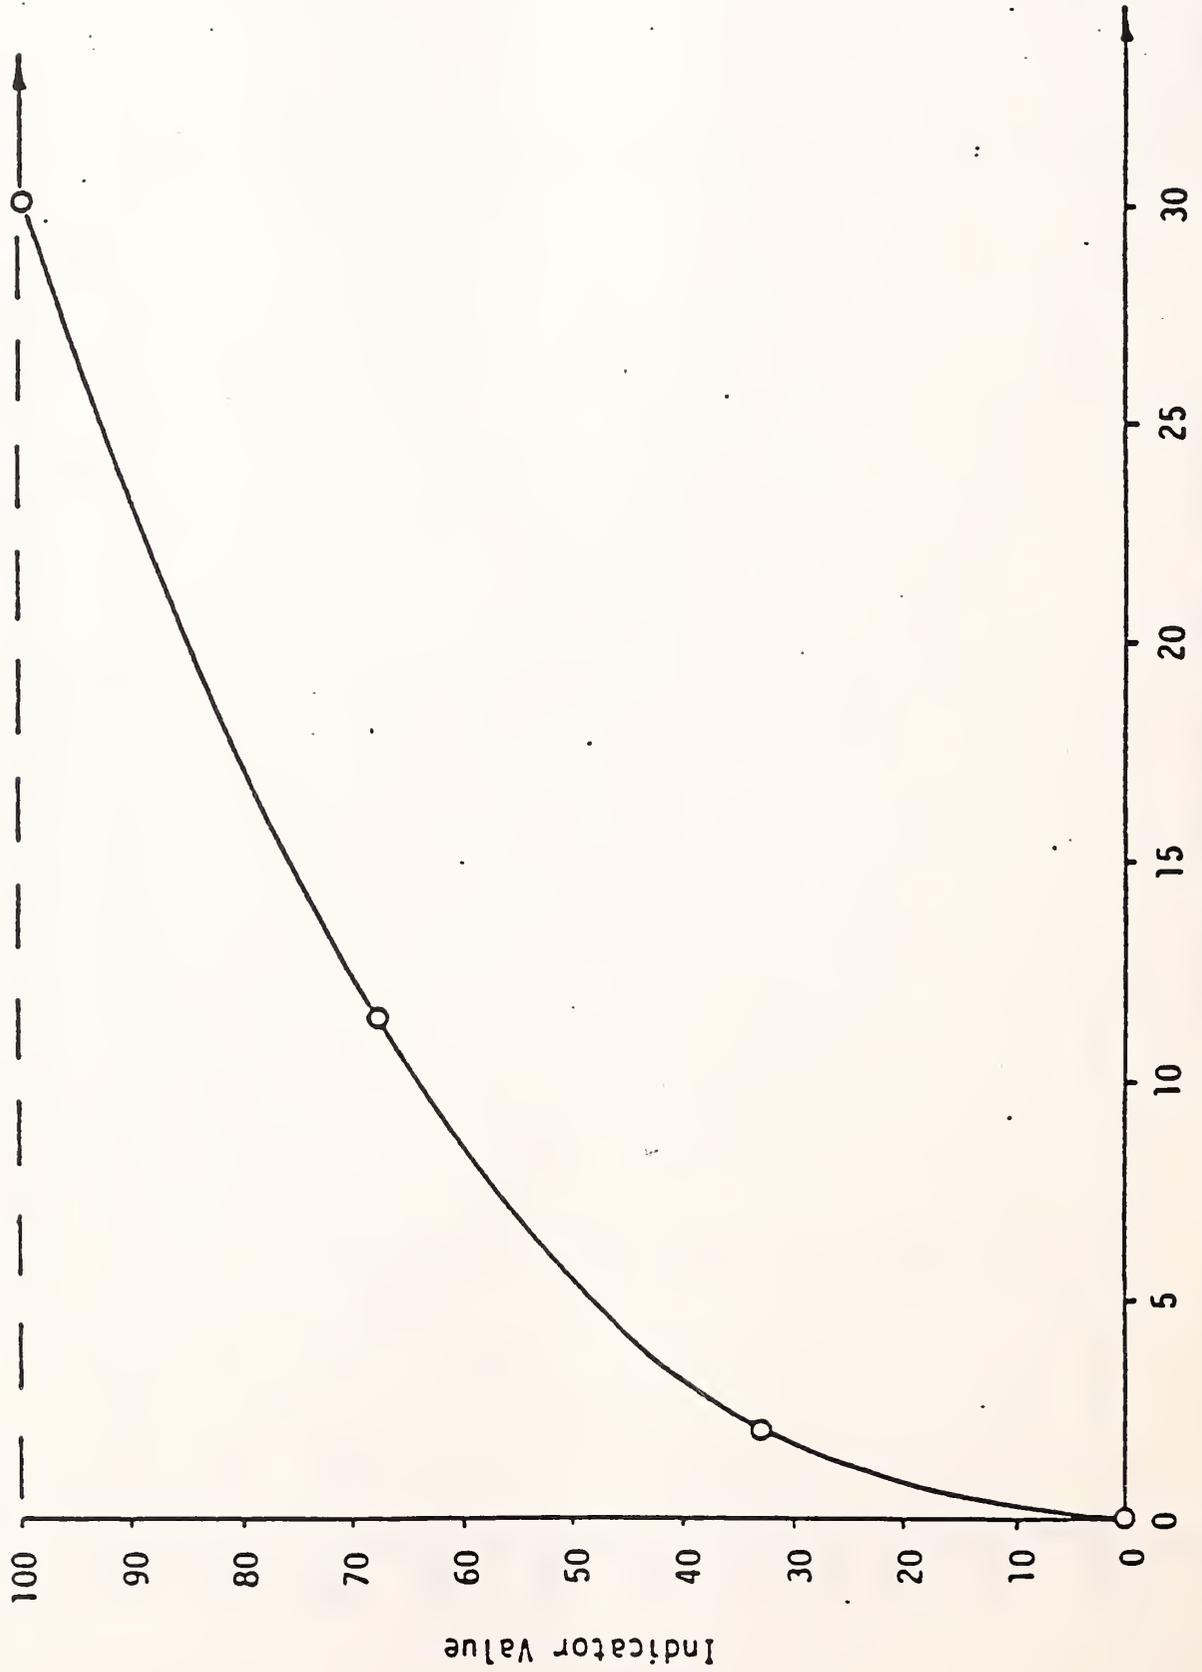
Figure 6. Severity Indicator

The FHWA report presents the relative severity index values for each type of accident. Once the type of accident has been established, Figure 6 enables the user to assess the indicator value. Figure 6 is a graphic plot of the average severity in thousands of dollars versus the indicator value which is based on a scale of 0 to 100.

Average RSI (in \$1000)

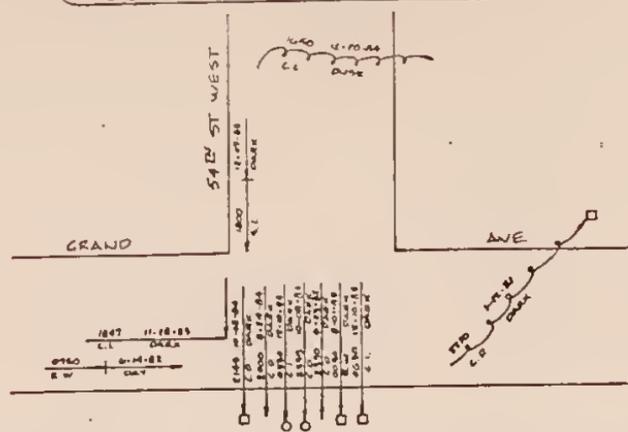
**COLLISION DIAGRAM**

ACCIDENTS / YEAR :	ROAD CONDITIONS - % OF TOTAL :
1981 = 0	5 DRY = 42%
1982 = 5	2 WET = 17%
1983 = 4	5 ICY = 42%
1984 = 3	
ACCIDENT TYPE - % OF TOTAL :	LIGHT CONDITIONS - % OF TOTAL :
0 HEAD ON = 0%	11 DARK = 92%
1 ANGLE = 8%	1 DAY = 8%
0 LEFT TURN = 0%	
0 SIDE SWP. = 0%	SEVERITY - % OF TOTAL :
2 REAR ENO = 17%	0 FATAL = 0%
9 SINGLE V = 75%	1 INJURY = 8%
0 OTHER = 0%	11 PROP OAH = 92%
WEATHER CONDITIONS - % OF TOTAL :	ALCOHOL INVOLVED
9 CLEAR = 75%	5 % TOTAL = 42%
2 RAIN = 17%	
1 SNOW = 8%	
0 FOG = 0%

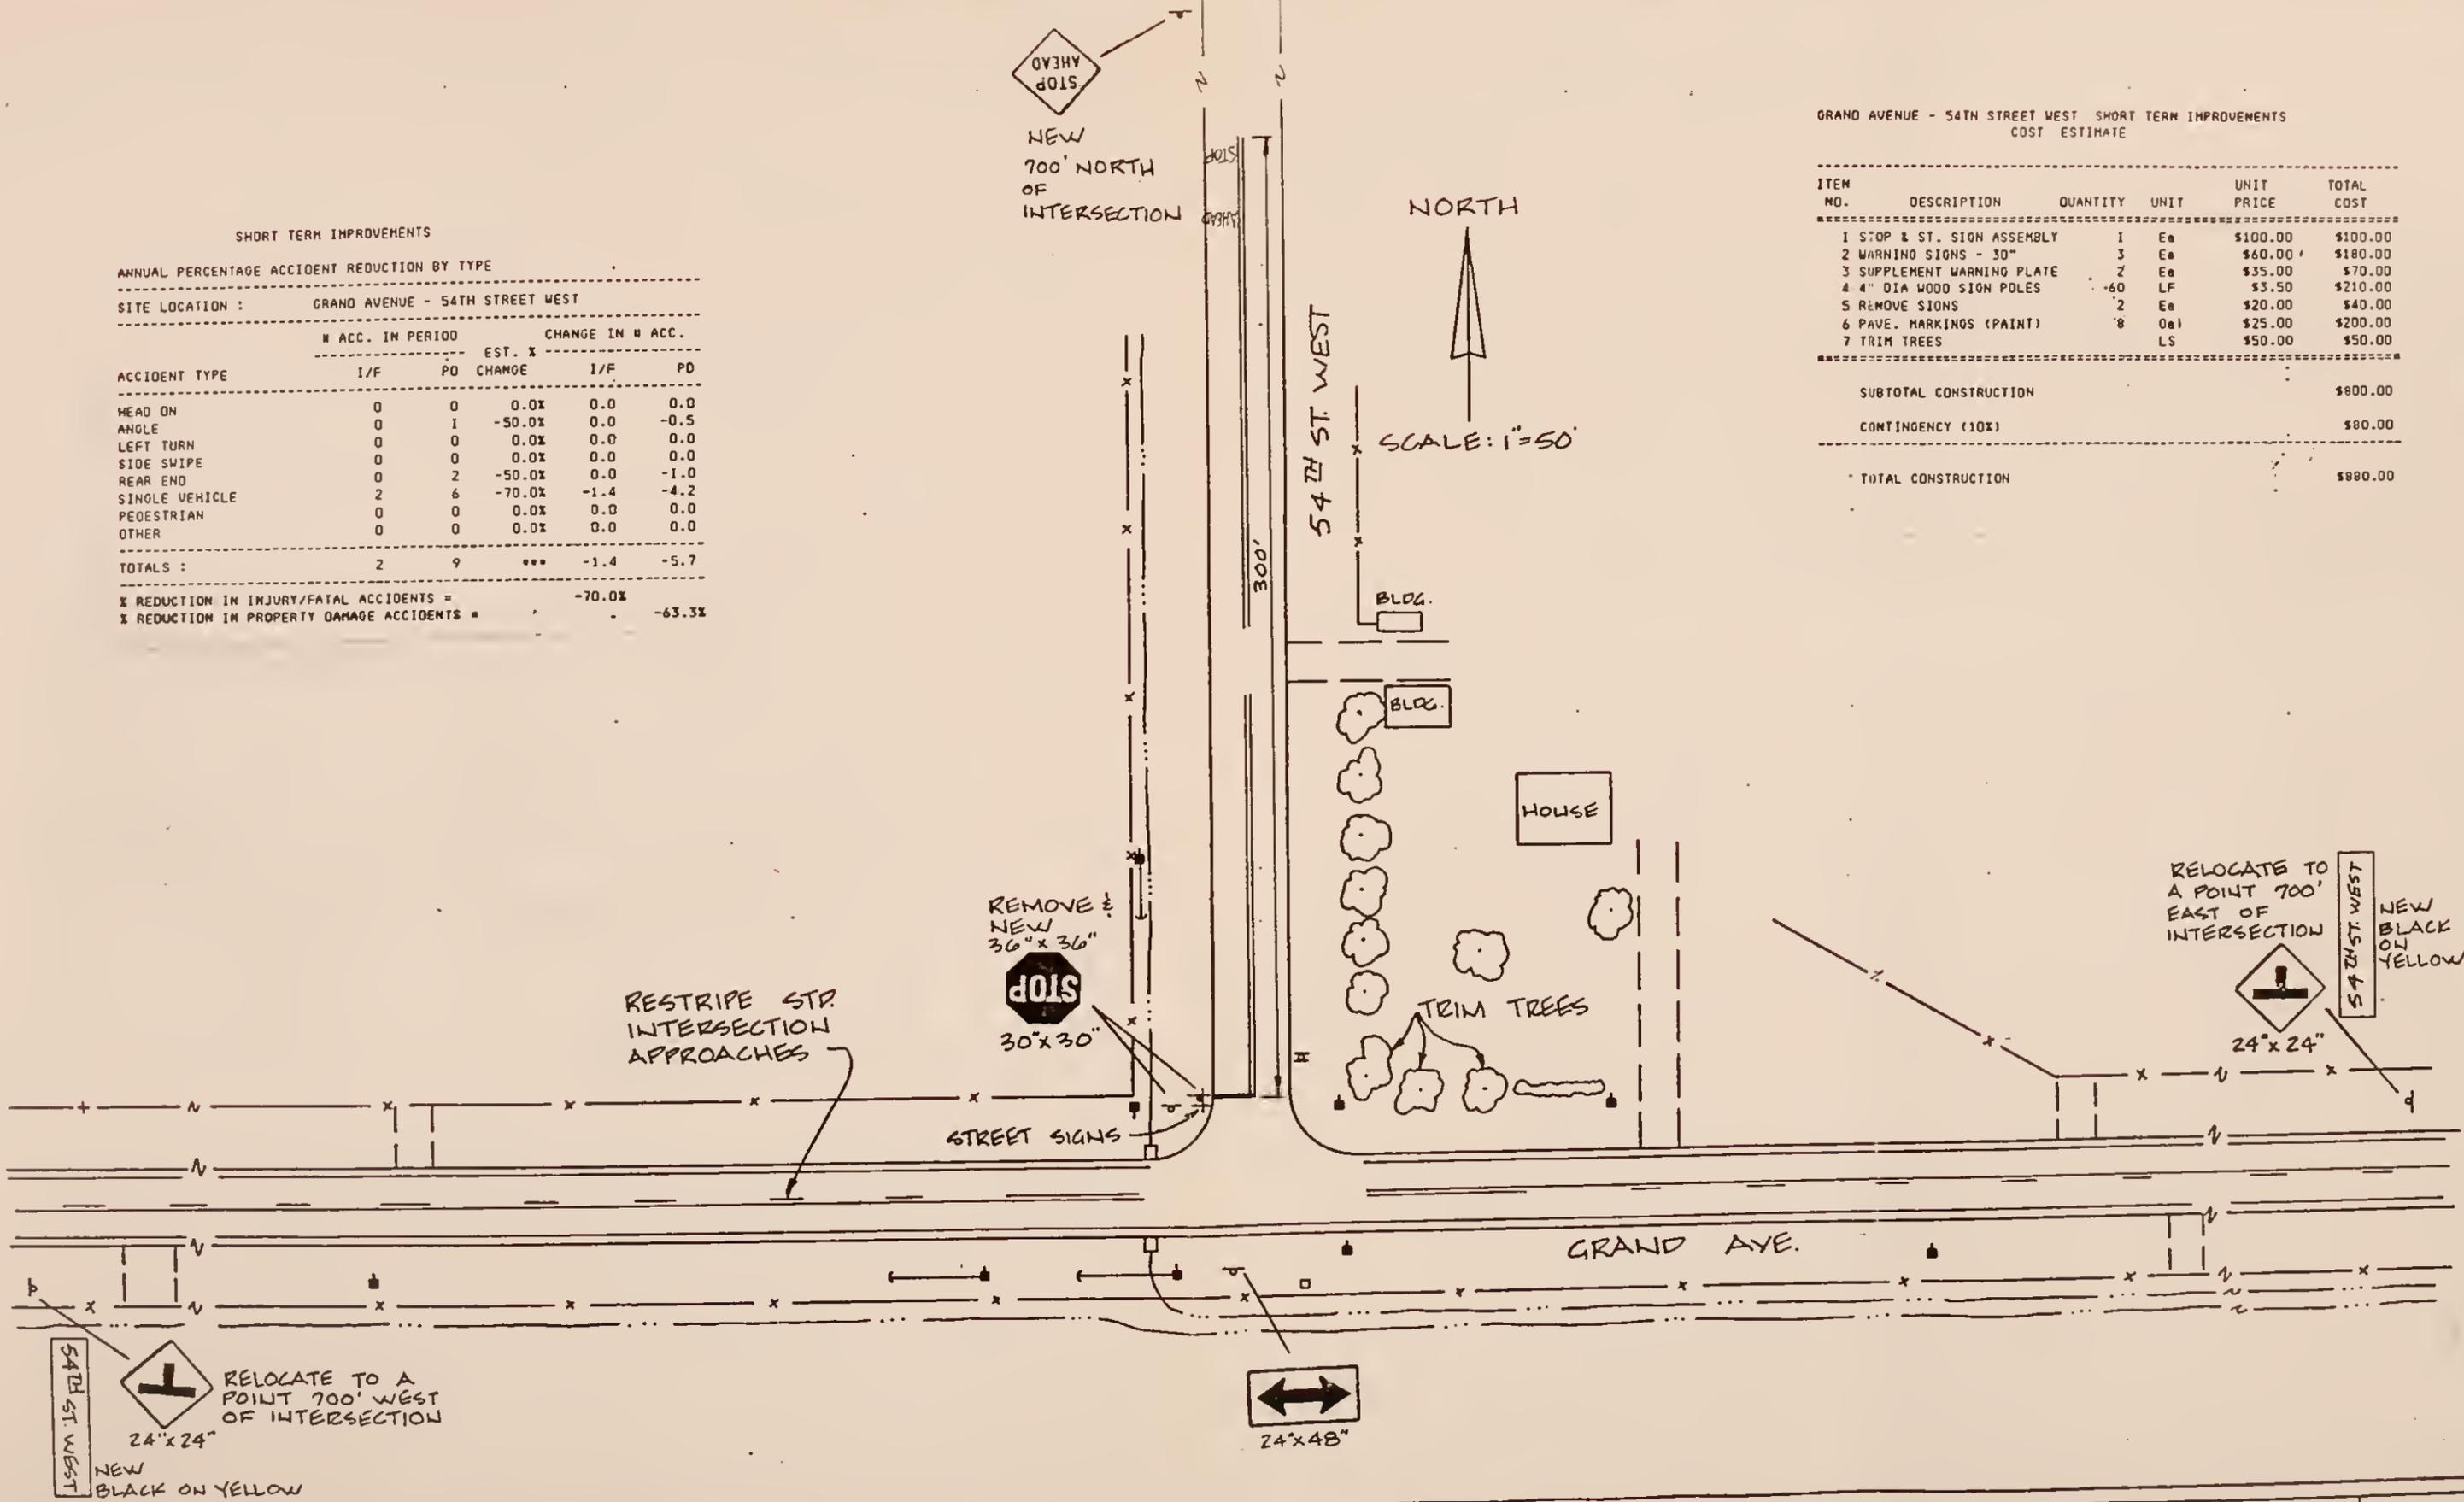
RELOCATE TO A POINT 700' WEST OF INTERSECTION  
 24" x 24"  
 NEW BLACK ON YELLOW

RELOCATE TO A POINT 700' EAST OF INTERSECTION  
 24" x 24"  
 NEW BLACK ON YELLOW

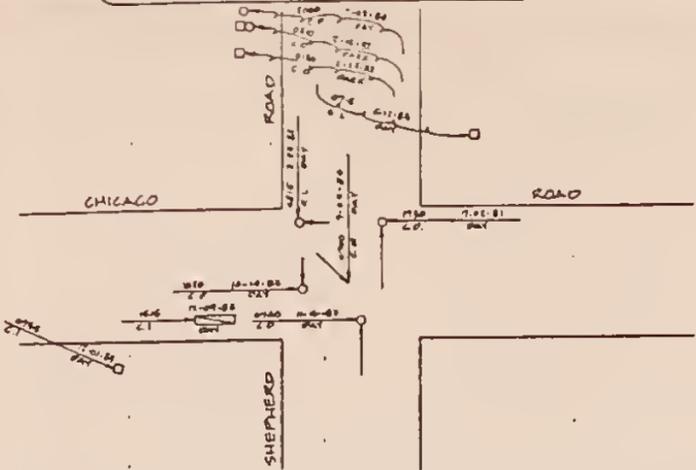
COLLISION DIAGRAM

ACCIDENTS / YEAR :		ROAD CONDITIONS - % OF TOTAL :	
1981=	1	7 DRY =	64%
1982=	4	0 WET =	0%
1983=	4	4 ICY =	36%
1984=	2	LIGHT CONDITIONS - % OF TOTAL :	
ACCIDENT TYPE - % OF TOTAL :		2 DARK =	18%
0 HEAD ON =	0%	9 DAY =	82%
4 ANGLE =	36%	SEVERITY - % OF TOTAL :	
0 LEFT TURN =	0%	0 FATAL =	0%
1 SIDE SWP. =	9%	6 INJURY =	55%
0 REAR END =	0%	5 PROP DAM =	45%
1 SINGLE V =	9%	ALCOHOL INVOLVED	
5 OTHER =	45%	2 % TOTAL =	18%
WEATHER CONDITIONS - % OF TOTAL :			
9 CLEAR =	82%		
1 RAIN =	9%		
1 SNOW =	9%		
0 FOG =	0%

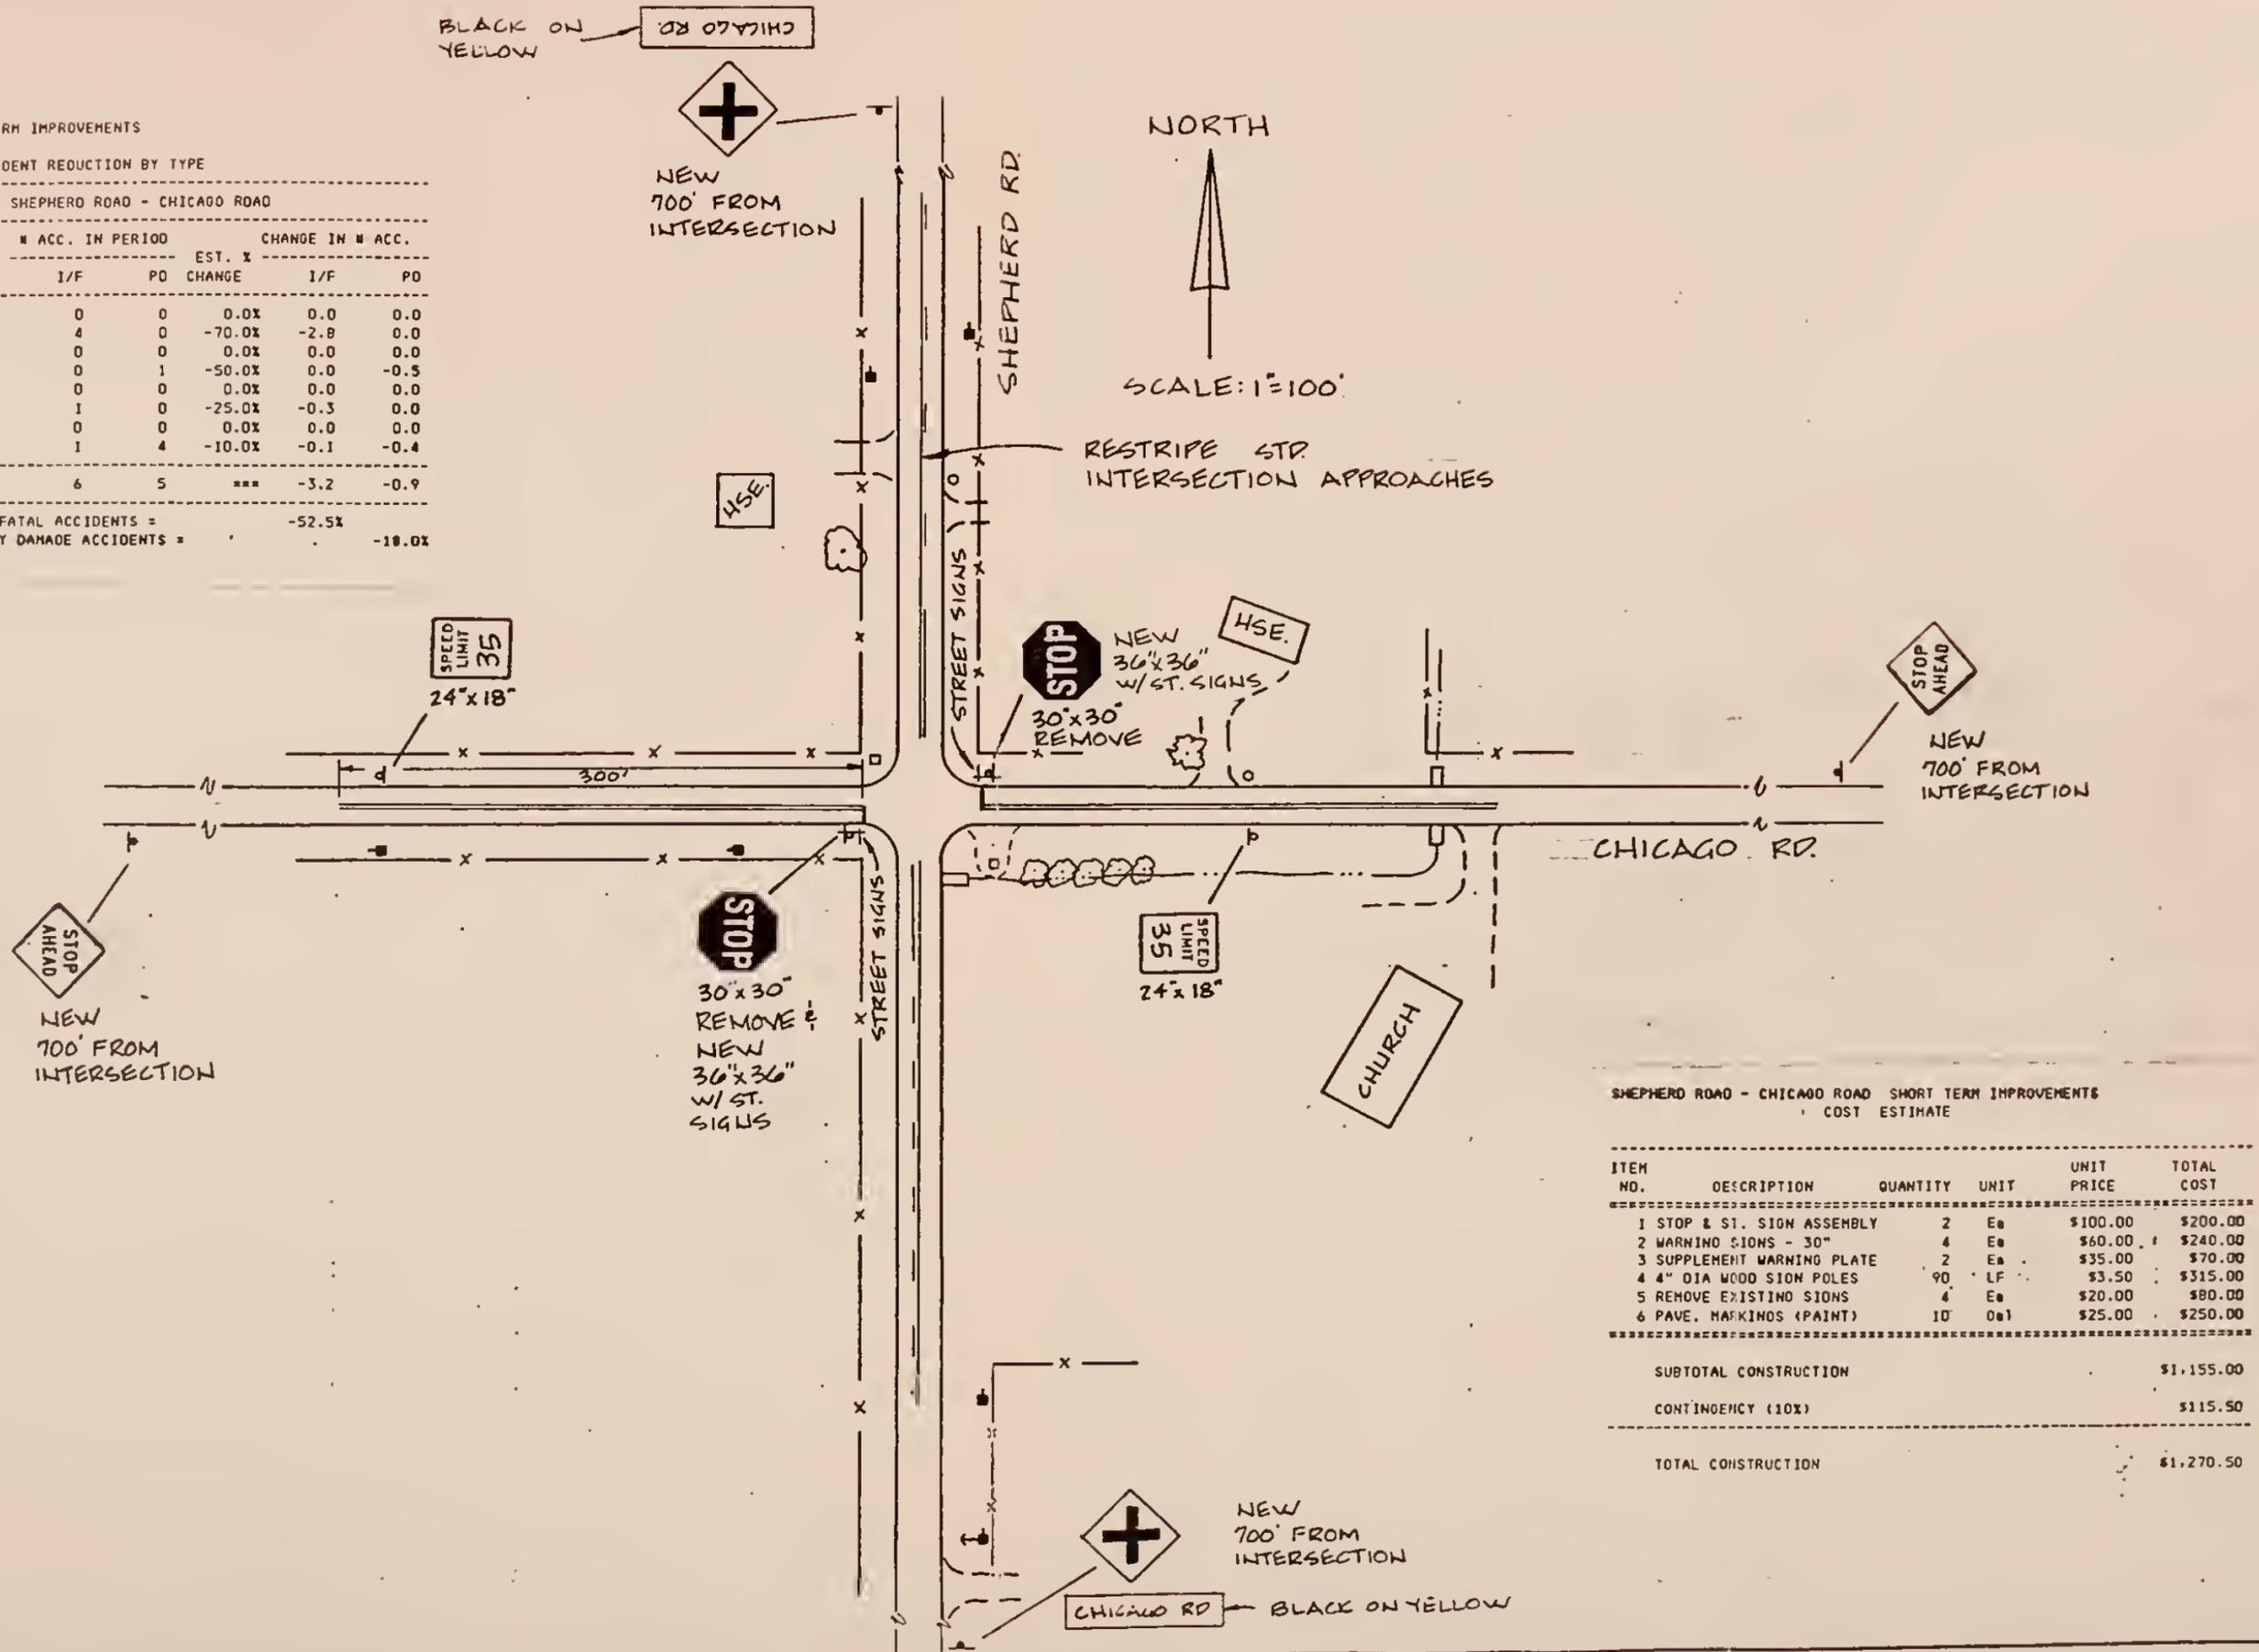
SHEPHERD ROAD - CHICAGO ROAD SHORT TERM IMPROVEMENTS COST ESTIMATE

% REDUCTION IN INJURY/FATAL ACCIDENTS = -52.5%  
 % REDUCTION IN PROPERTY DAMAGE ACCIDENTS = -18.0%

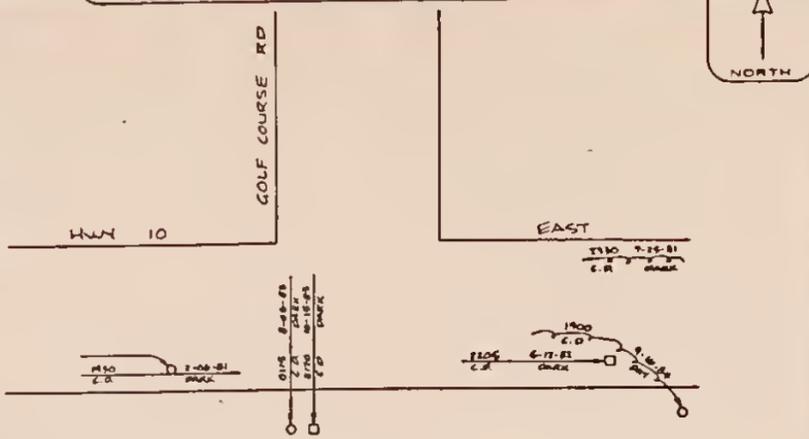
COLLISION DIAGRAM

ACCIDENTS / YEAR :	ROAD CONDITIONS - % OF TOTAL :
1981 = 2	6 DRY = 100%
1982 = 1	0 WET = 0%
1983 = 2	0 ICY = 0%
1984 = 1	
ACCIDENT TYPE - % OF TOTAL :	LIGHT CONDITIONS - % OF TOTAL :
0 HEAD ON = 0%	5 DARK = 83%
0 ANGLE = 0%	1 DAY = 17%
0 LEFT TURN = 0%	
1 SIDE SWP. = 17%	SEVERITY - % OF TOTAL :
0 REAR END = 0%	0 FATAL = 0%
3 SINGLE V = 50%	3 INJURY = 50%
2 OTHER = 33%	3 PROP DAN = 50%
WEATHER CONDITIONS - % OF TOTAL :	ALCOHOL INVOLVED
6 CLEAR = 100%	4 % TOTAL = 67%
0 RAIN = 0%	
0 SNOW = 0%	
0 FOG = 0%

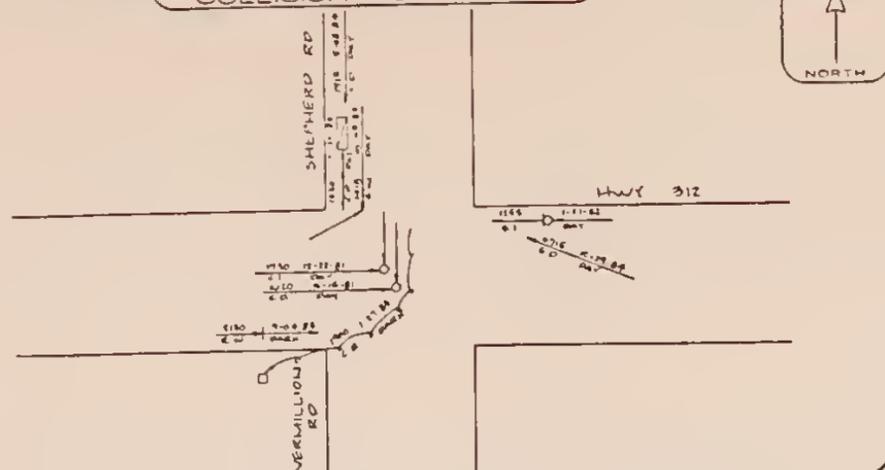
COLLISION DIAGRAM

STATISTICS	
ACCIDENTS / YEAR :	ROAD CONDITIONS - % OF TOTAL :
1981 = 3	7 DRY = 58%
1982 = 3	3 WET = 25%
1983 = 3	2 ICY = 17%
1984 = 3	LIGHT CONDITIONS - % OF TOTAL :
ACCIDENT TYPE - % OF TOTAL :	3 DARK = 25%
0 HEAD ON = 0%	9 DAY = 75%
4 ANGLE = 33%	SEVERITY - % OF TOTAL :
1 LEFT TURN = 8%	0 FATAL = 0%
0 SIDE SWP. = 0%	4 INJURY = 33%
3 REAR END = 25%	8 PROP OAH = 67%
3 SINGLE V = 25%	WEATHER CONDITIONS - % OF TOTAL :
1 OTHER = 8%	0 CLEAR = 67%
WEATHER CONDITIONS - % OF TOTAL :	1 RAIN = 8%
0 CLEAR = 67%	3 SNOW = 25%
1 RAIN = 8%	0 FOG = 0%
3 SNOW = 25%	ALCOHOL INVOLVED
0 FOG = 0%	3 % TOTAL = 25%

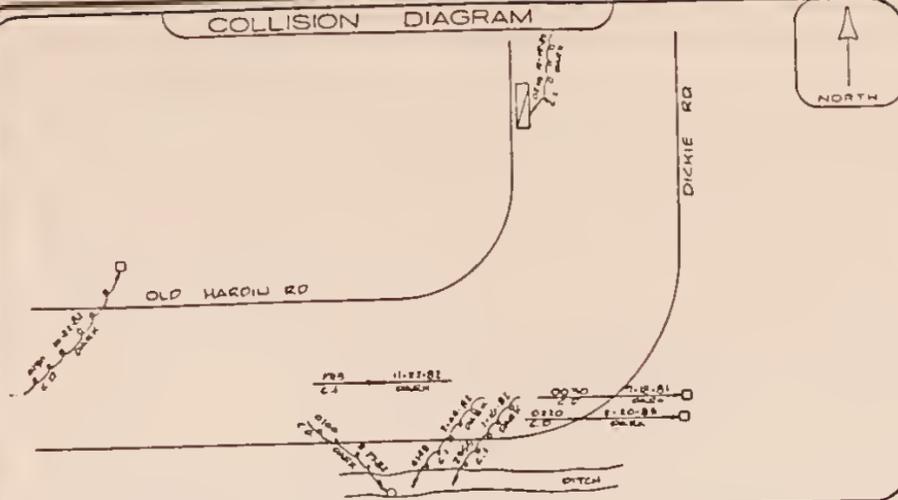
COLLISION DIAGRAM

ACCIDENTS / YEAR :	ROAD CONDITIONS - % OF TOTAL :
1981 = 1	4 DRY = 50%
1982 = 6	0 WET = 0%
1983 = 1	4 ICY = 50%
1984 = 0	
ACCIDENT TYPE - % OF TOTAL :	LIGHT CONDITIONS - % OF TOTAL :
1 HEAD ON = 13%	0 DARK = 0%
0 ANGLE = 0%	8 DAT = 100%
0 LEFT TURN = 0%	
0 SIDE SWP. = 0%	SEVERITY - % OF TOTAL :
0 REAR END = 0%	0 FATAL = 0%
3 SINGLE V = 38%	1 INJUR = 13%
4 OTHER = 50%	7 PRDP OAH = 88%
WEATHER CONDITIONS - % OF TOTAL :	ALCDHDL INVOLVED
8 CLEAR = 100%	4 % TOTAL = 50%
0 RAIN = 0%	
0 SNOW = 0%	
0 FOG = 0%

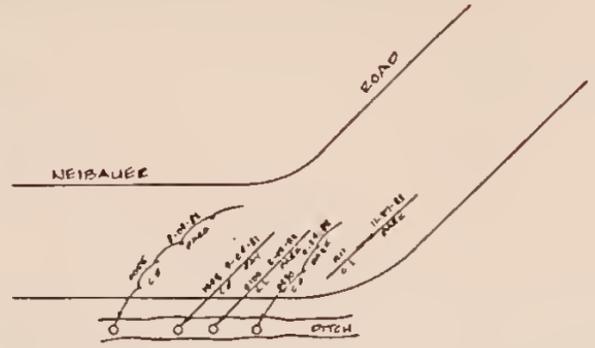
COLLISION DIAGRAM

ACCIDENTS / YEAR :	ROAD CONDITIONS - % OF TOTAL :
1991= 1	3 DRY = 60%
1992= 2	0 WET = 0%
1993= 2	2 ICY = 40%
1994= 0	
ACCIDENT TYPE - % OF TOTAL :	LIGHT CONDITIONS - % OF TOTAL :
1 HEAD ON = 20%	4 DARK = 80%
0 ANGLE = 0%	1 DAY = 20%
0 LEFT TURN = 0%	
0 SIDE SWP. = 0%	SEVERITY - % OF TOTAL :
0 REAR END = 0%	0 FATAL = 0%
4 SINGLE V = 80%	4 INJURY = 80%
0 OTHER = 0%	1 PROP DAM = 20%
WEATHER CONDITIONS - % OF TOTAL :	ALCOHOL INVOLVED
4 CLEAR = 80%	4 % TOTAL = 80%
0 RAIN = 0%	
1 SNOW = 20%	
0 FOG = 0%

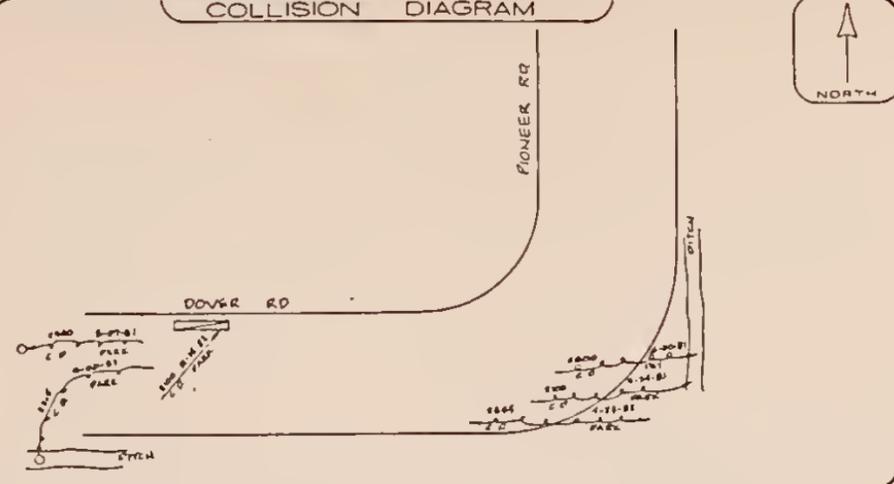
COLLISION DIAGRAM

ACCIDENTS / YEAR :	ROAD CONDITIONS - % OF TOTAL :
1981 = 4	6 DRY = 100%
1982 = 2	0 WET = 0%
1983 = 0	0 ICY = 0%
1984 = 0	
ACCIDENT TYPE - % OF TOTAL :	LIGHT CONDITIONS - % OF TOTAL :
0 HEAD ON = 0%	5 DARK = 83%
0 ANGLE = 0%	1 DAY = 17%
0 LEFT TURN = 0%	
0 SIDE SWP. = 0%	SEVERITY - % OF TOTAL :
0 REAR END = 0%	0 FATAL = 0%
5 SINGLE V = 83%	2 INJURY = 33%
1 OTHER = 17%	4 PROP DAM = 67%
WEATHER CONDITIONS - % OF TOTAL :	ALCOHOL INVOLVED
6 CLEAR = 100%	3 % TOTAL = 50%
0 RAIN = 0%	
0 SNOW = 0%	
0 FOG = 0%

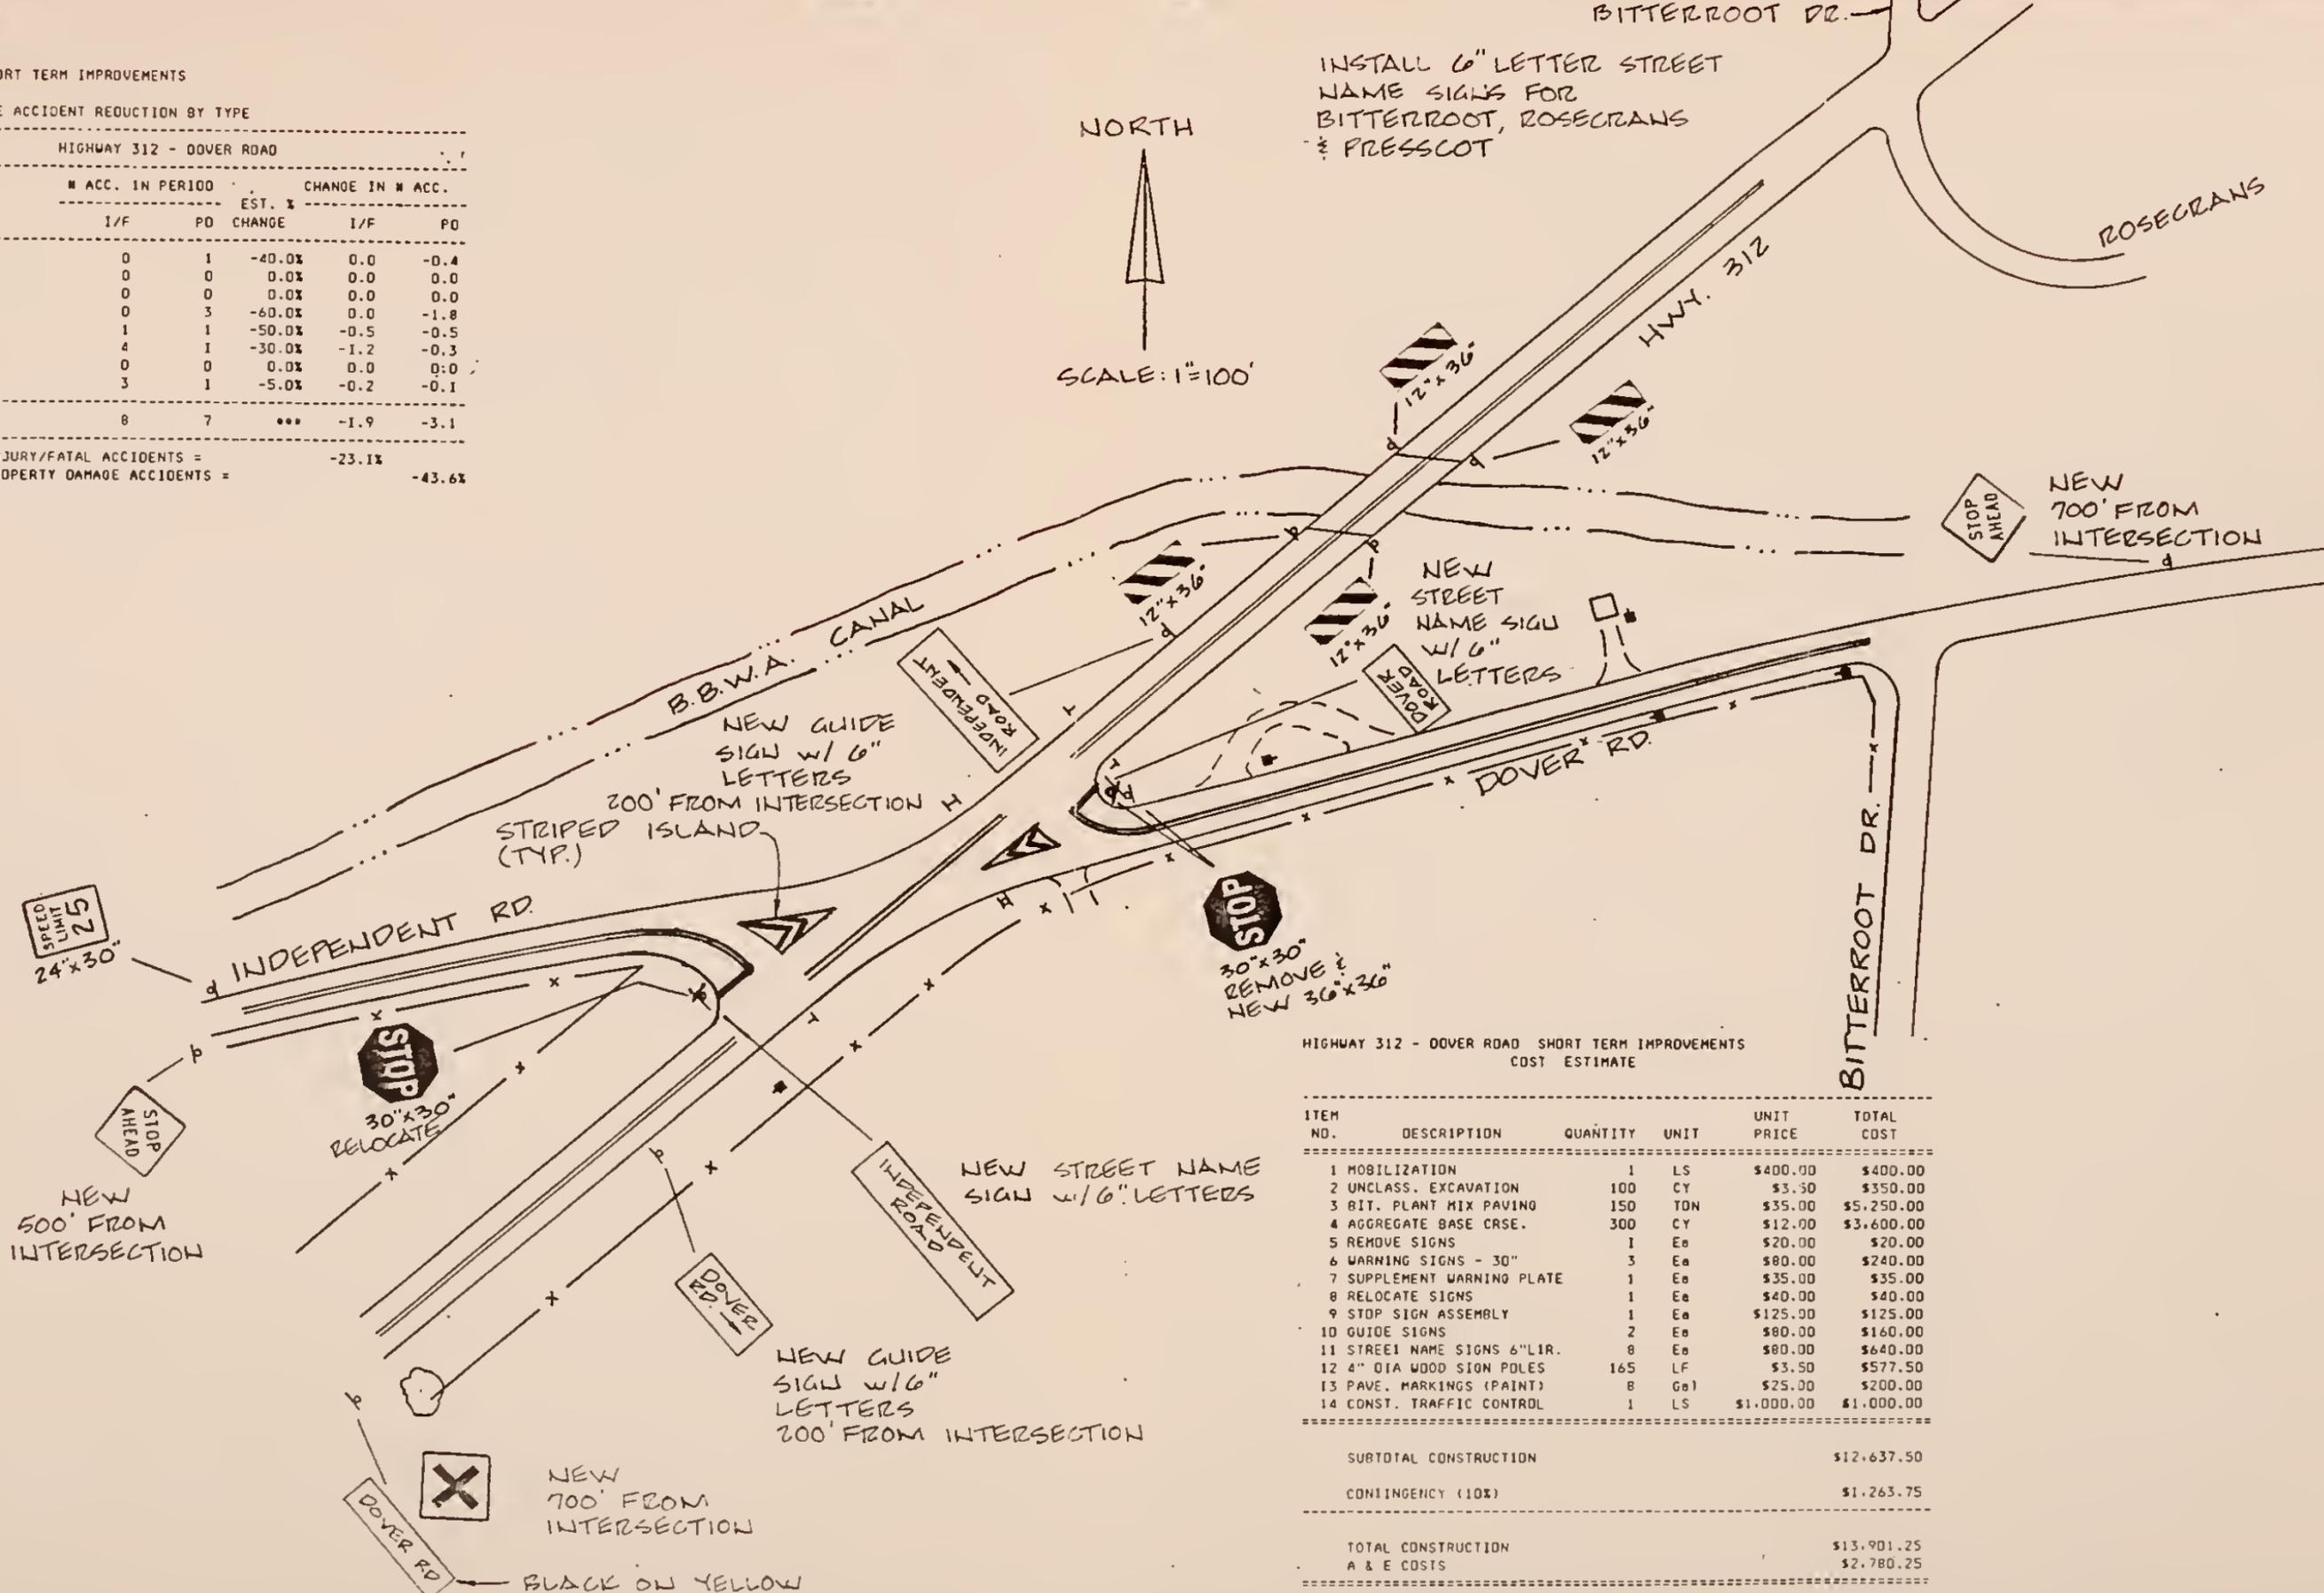
HIGHWAY 312 - DOVER ROAD SHORT TERM IMPROVEMENTS COST ESTIMATE

INSTALL 6" LETTER STREET NAME SIGNS FOR BITTERROOT, ROSECRANS & PRESSCOT

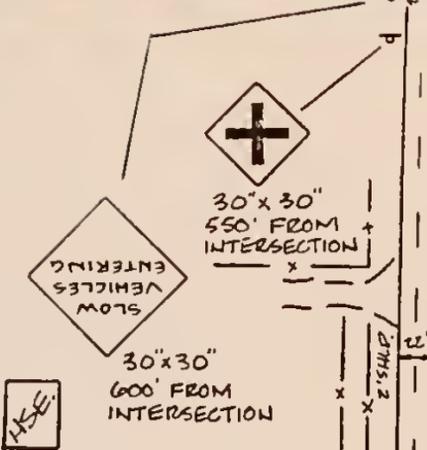
COLLISION DIAGRAM

ACCIDENTS / YEAR :		ROAD CONDITIONS - % OF TOTAL :	
1981 = 1	4 DRY = 67%	0 WET = 0%	LIGHT CONDITIONS - % OF TOTAL :
1982 = 2	0 WET = 0%	2 ICY = 33%	1 DARK = 17%
1983 = 1	2 ICY = 33%	5 DAY = 83%	SEVERITY - % OF TOTAL :
1984 = 2	1 DARK = 17%	5 DAY = 83%	0 FATAL = 0%
ACCIDENT TYPE - % OF TOTAL :		1 INJURY = 17%	
0 HEAD ON = 0%	4 ANGLE = 67%	5 PROP DAM = 83%	
0 LEFT TURN = 0%	1 SIDE SWP. = 17%	ALCONOL INVOLVED	
0 REAR END = 0%	0 SINGLE V = 0%	1 % TOTAL = 17%	
1 OTHER = 17%	WEATHER CONDITIONS - % OF TOTAL :		
6 CLEAR = 100%		0 RAIN = 0%	
0 SNOW = 0%		0 FOG = 0%

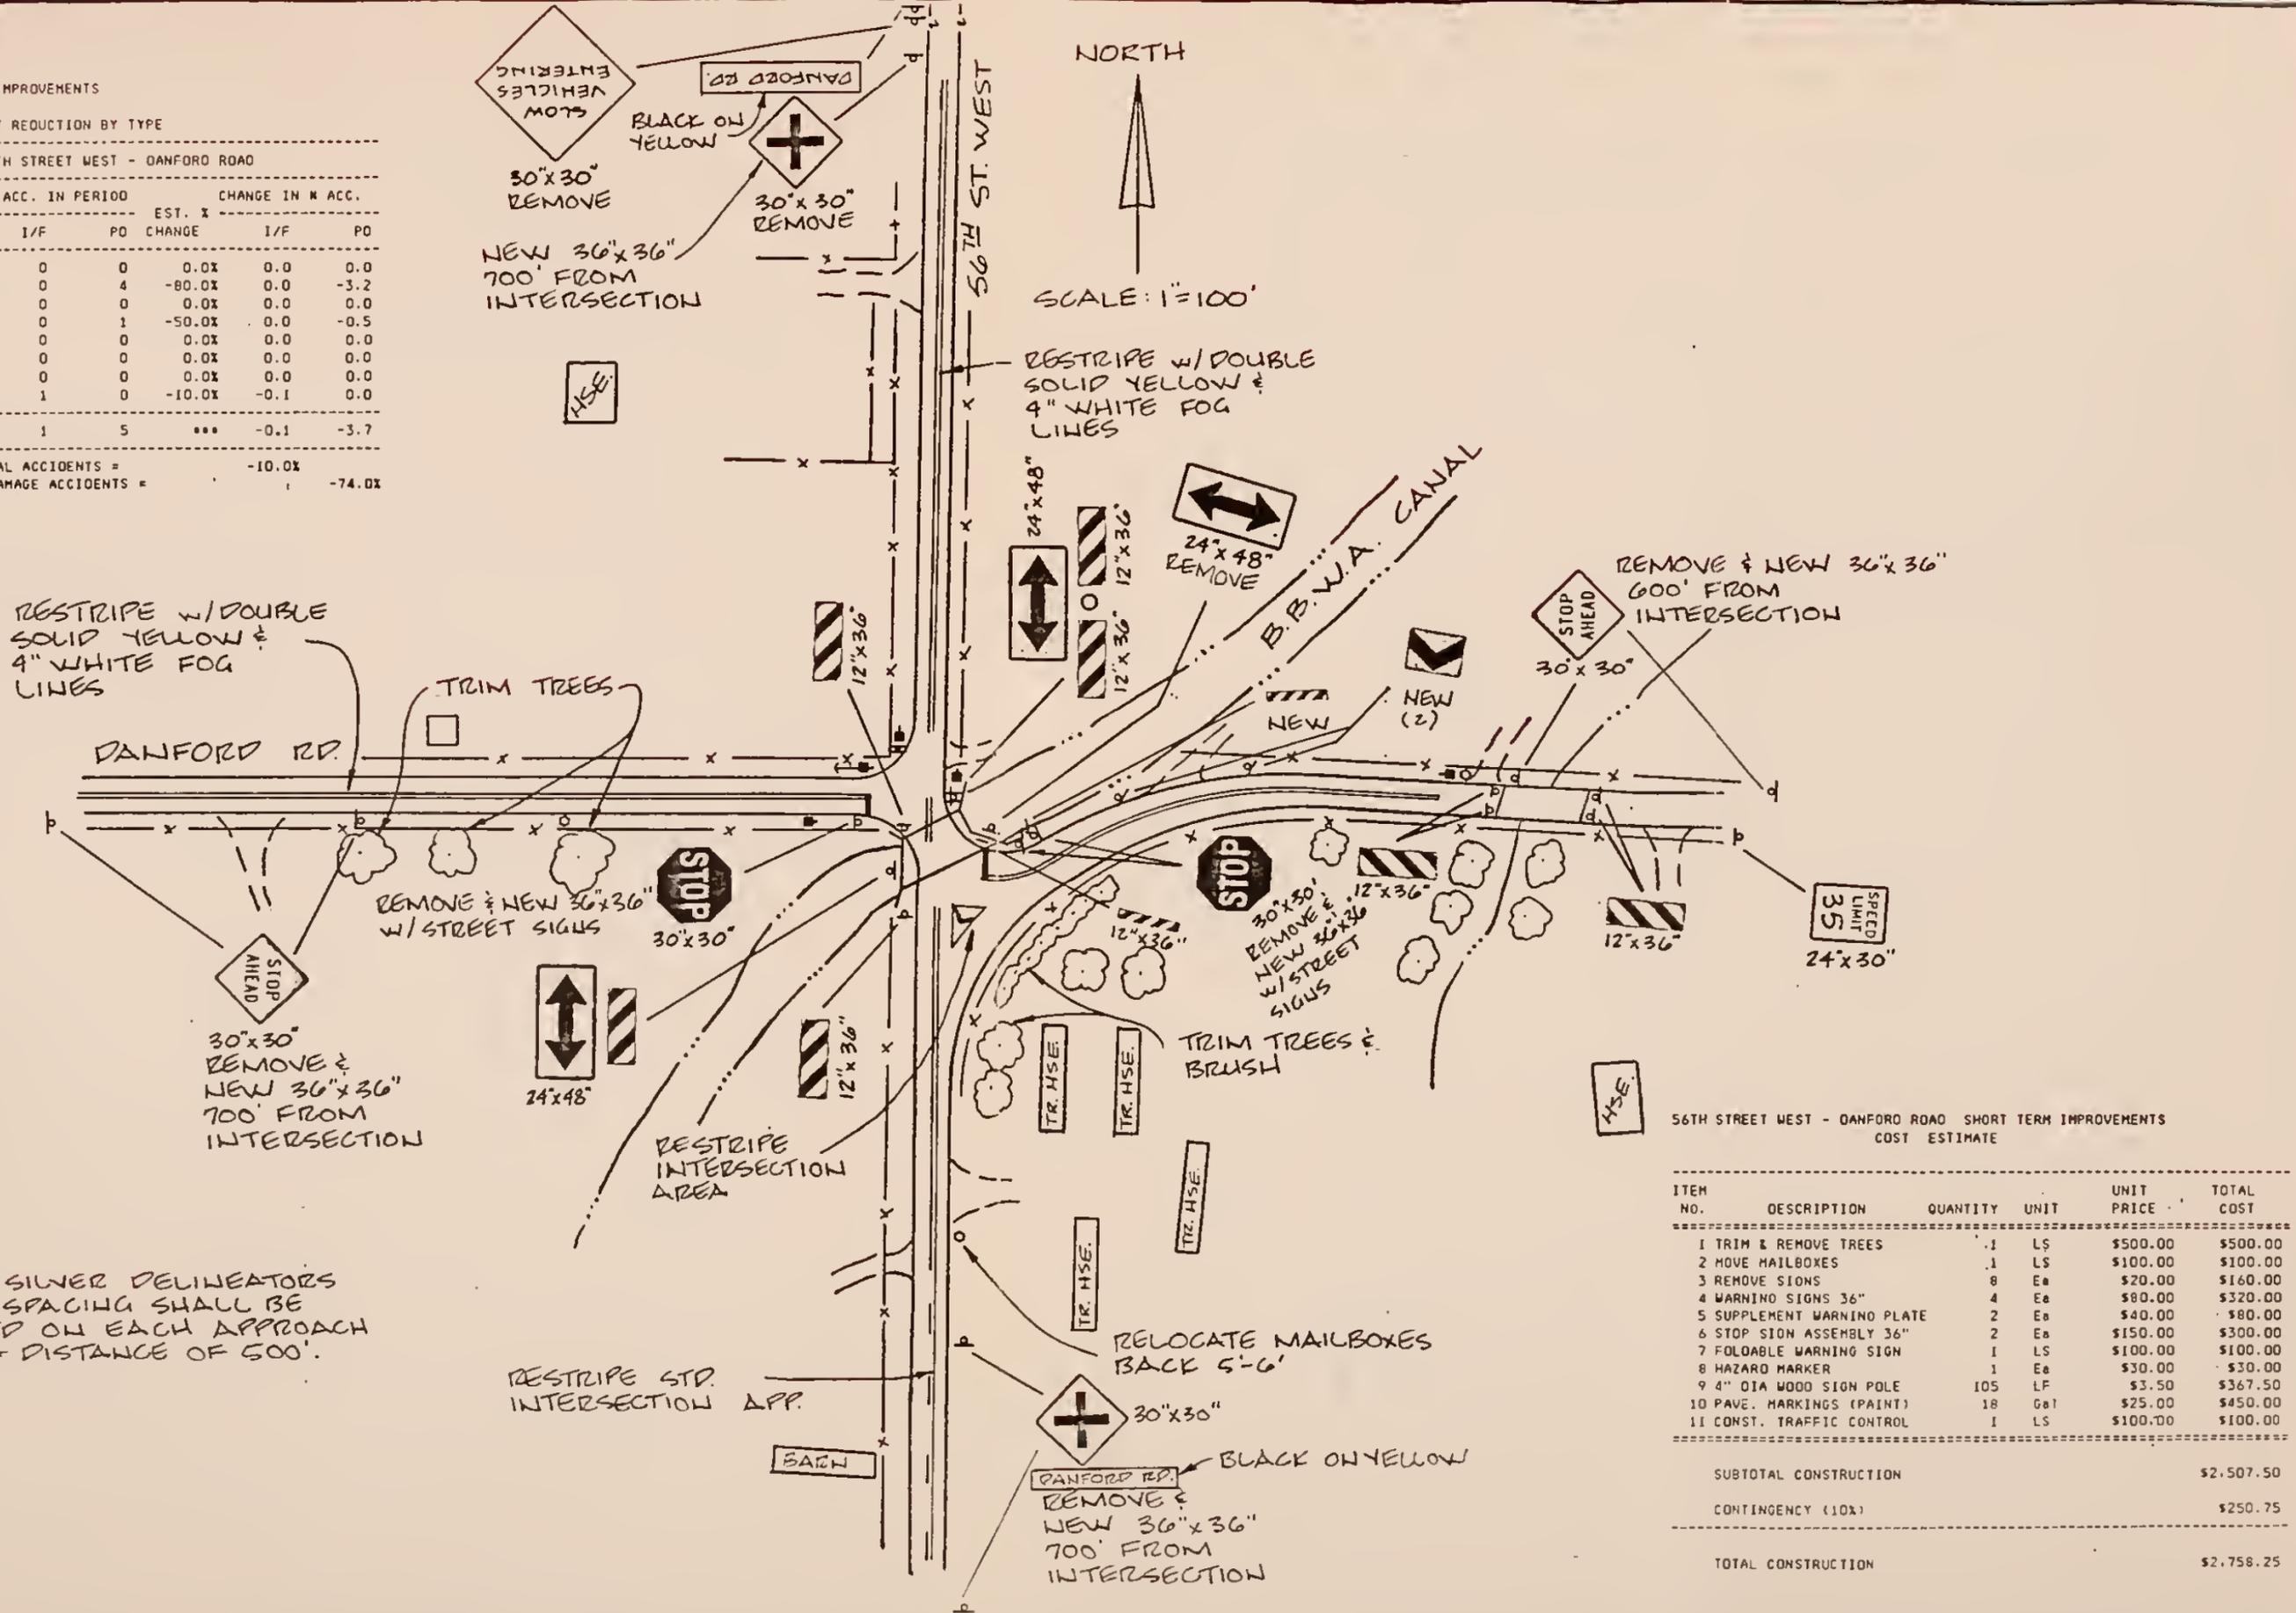
NOTE:  
 NEW SILVER DELINEATORS @ 100' SPACING SHALL BE PLACED ON EACH APPROACH FOR A DISTANCE OF 500'.

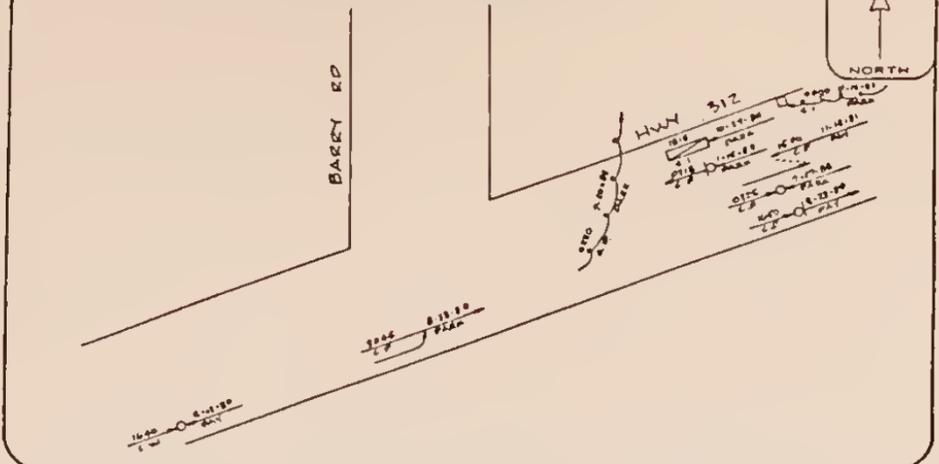
COLLISION DIAGRAM

ACCIDENTS / YEAR :	ROAD CONDITIONS - % OF TOTAL :
1981 = 1	4 DRY = 67%
1982 = 1	1 WET = 11%
1983 = 3	2 ICY = 22%
1984 = 4	
ACCIDENT TYPE - % OF TOTAL :	LIGHT CONDITIONS - % OF TOTAL :
2 HEAD ON = 22%	6 DARK = 67%
0 ANGLE = 0%	3 DAY = 33%
0 LEFT TURN = 0%	
1 SIDE SWP. = 11%	SEVERITY - % OF TOTAL :
2 REAR END = 22%	0 FATAL = 0%
1 SINGLE V = 11%	4 INJURY = 44%
3 OTHER = 33%	5 PROP DAM = 56%
WEATHER CONDITIONS - % OF TOTAL :	
7 CLEAR = 78%	ALCOHOL INVOLVED
0 RAIN = 0%	2 % TOTAL = 22%
2 SNOW = 22%	
0 FOG = 0%

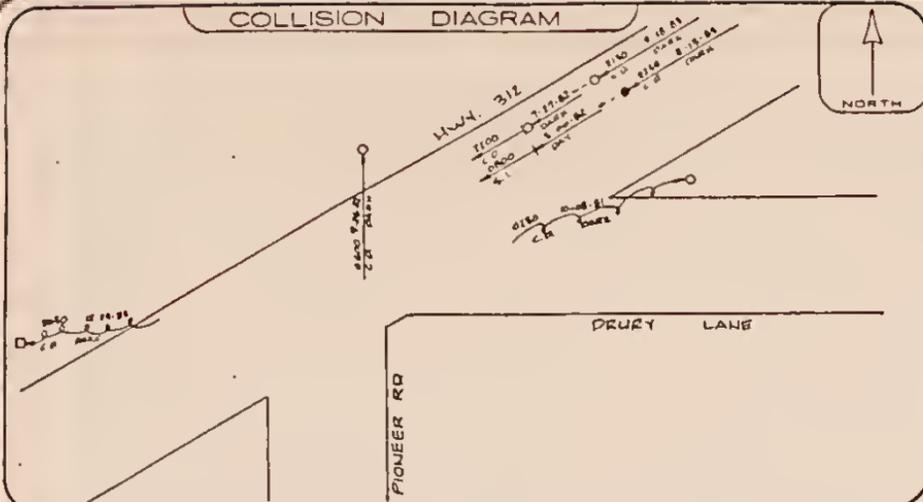
COLLISION DIAGRAM

ACCIDENTS / YEAR :	ROAD CONDITIONS - % OF TOTAL :
1981 = 1	6 DRY = 86%
1982 = 3	0 WET = 0%
1983 = 3	1 ICT = 14%
1984 = 0	
ACCIDENT TYPE - % OF TOTAL :	LIGHT CONDITIONS - % OF TOTAL :
0 HEAD ON = 0%	6 DARK = 86%
0 ANGLE = 0%	1 DAY = 14%
0 LEFT TURN = 0%	
0 SIDE SWP. = 0%	SEVERITY - % OF TOTAL :
2 REAR END = 29%	1 FATAL = 14%
2 SINGLE V = 29%	4 INJURY = 57%
3 OTHER = 43%	2 PROP DAM = 29%
WEATHER CONDITIONS - % OF TOTAL :	ALCOHOL INVOLVED
5 CLEAR = 71%	4 % TOTAL = 57%
0 RAIN = 0%	
2 SNOW = 29%	
0 FOI = 0%

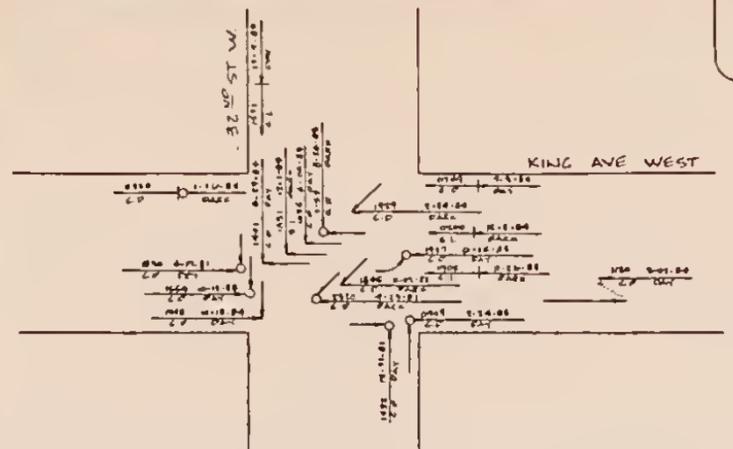
COLLISION DIAGRAM

ACCIDENTS / YEAR :	ROAD CONDITIONS - % OF TOTAL :
1981 = 3	15 DRY = 79%
1982 = 1	0 WET = 0%
1983 = 7	4 ICY = 21%
1984 = 8	
ACCIDENT TYPE - % OF TOTAL :	LIGHT CONDITIONS - % OF TOTAL :
0 HEAD ON = 0%	8 DARK = 42%
12 ANGLE = 63%	11 DAY = 58%
1 LEFT TURN = 5%	
0 SIDE SWP. = 0%	SEVERITY - % OF TOTAL :
5 REAR END = 26%	0 FATAL = 0%
0 SINGLE V = 0%	8 INJURY = 42%
1 OTHER = 5%	11 PROP DAM = 56%
WEATHER CONDITIONS - % OF TOTAL :	ALCOHOL INVOLVED
17 CLEAR = 89%	7 % TOTAL = 0%
0 RAIN = 0%	
2 SNOW = 11%

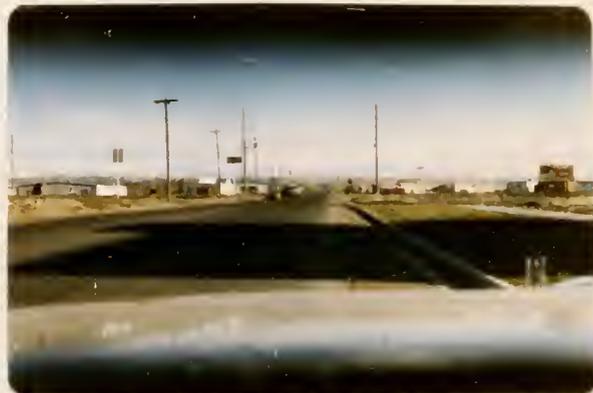
S 32<sup>ND</sup> ST W SOUTH ↑

**Traffic Operations.** During traffic observation periods at the peak evening hour and during mid afternoon, it was noted that delay for both side street (32nd St. W.) traffic and King Ave W. left turn traffic is beginning to be significant. Further traffic volume increases will undoubtedly stress driver tolerance to a point where gap acceptance will be made without sufficient caution and accidents will increase proportionately.
